NBSIR 82-2509

Corrosion Evaluation of Underground Telephone Cable Shielding Materials

June 1982

J. L. Fink, E. Escalante, and W. F. Gerhold

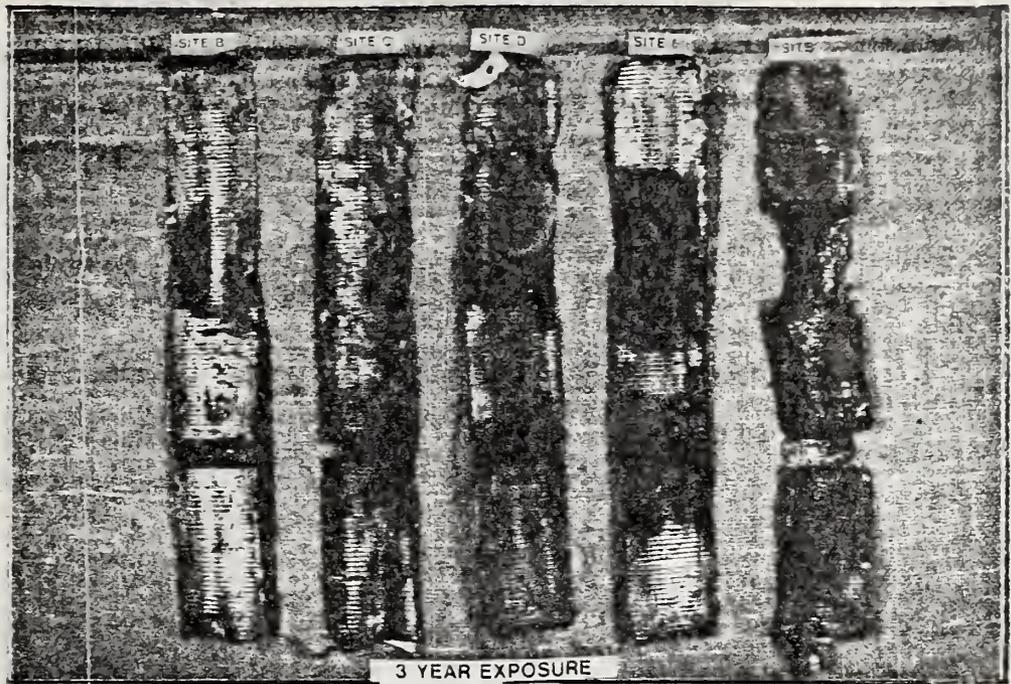
Figure 30. Outer Shield; System 87, Sites B,C,D,E, and G, left to right, exposed for three years. Dark areas indicate corrosion on specimens with severe corrosion on the specimens from Sites C and G.

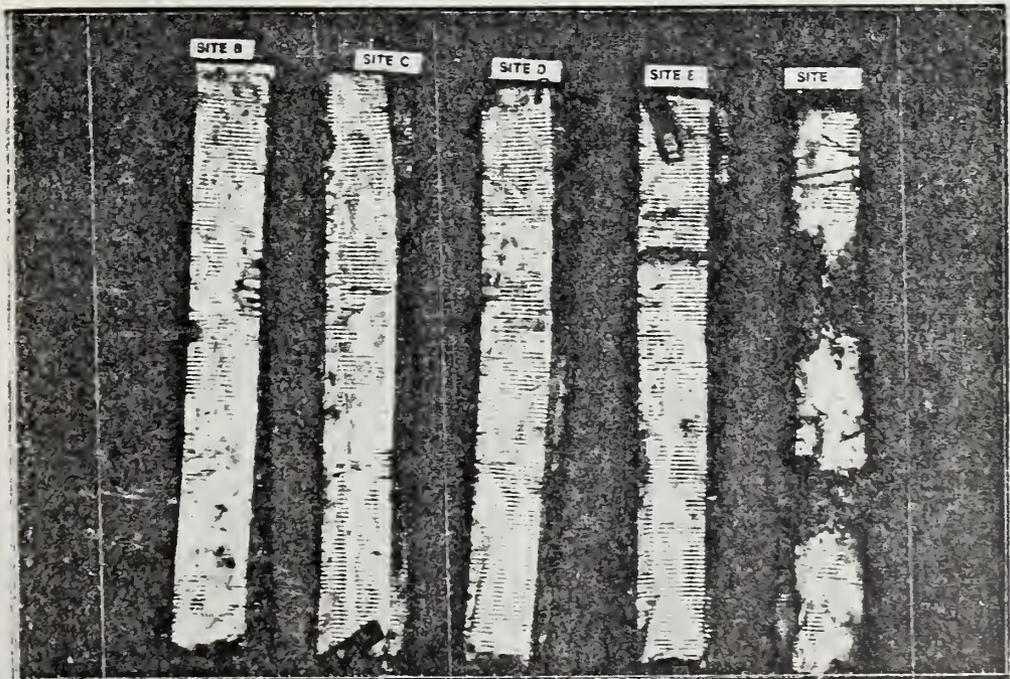
Figure 31. Inner Shield; System 87, Sites B,C,D,E, and G, left to right, exposed for three years. Severe degradation on the specimen from Site G.

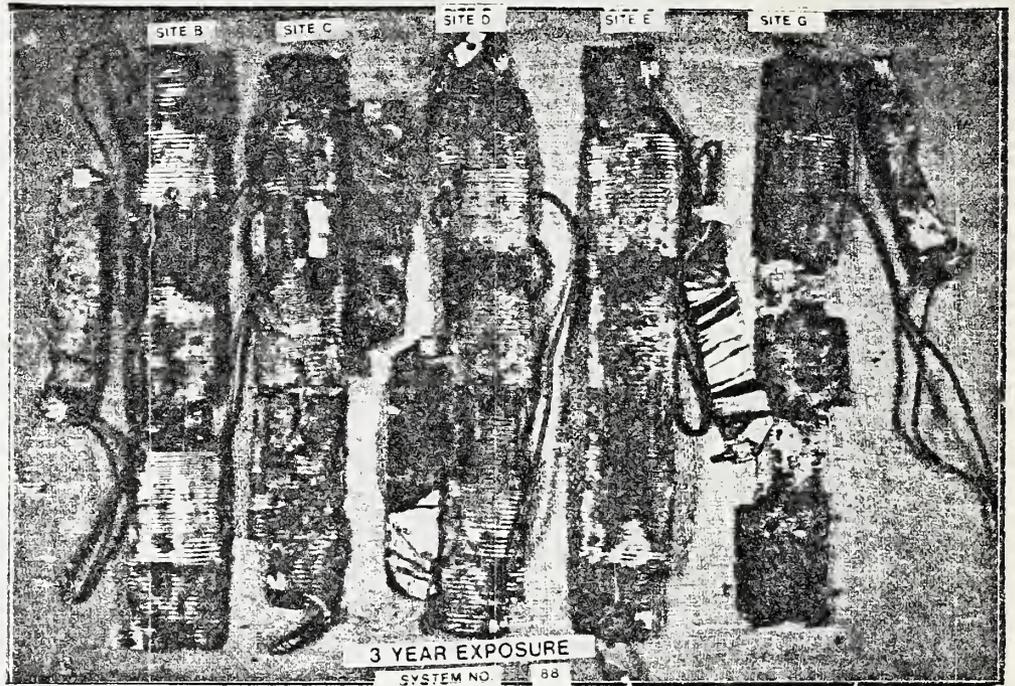
Figure 32. Outer Shield; System 88, Sites B,C,D,E, and G, left to right, exposed for three years. Coupling this system to copper accelerated corrosion on all specimens.

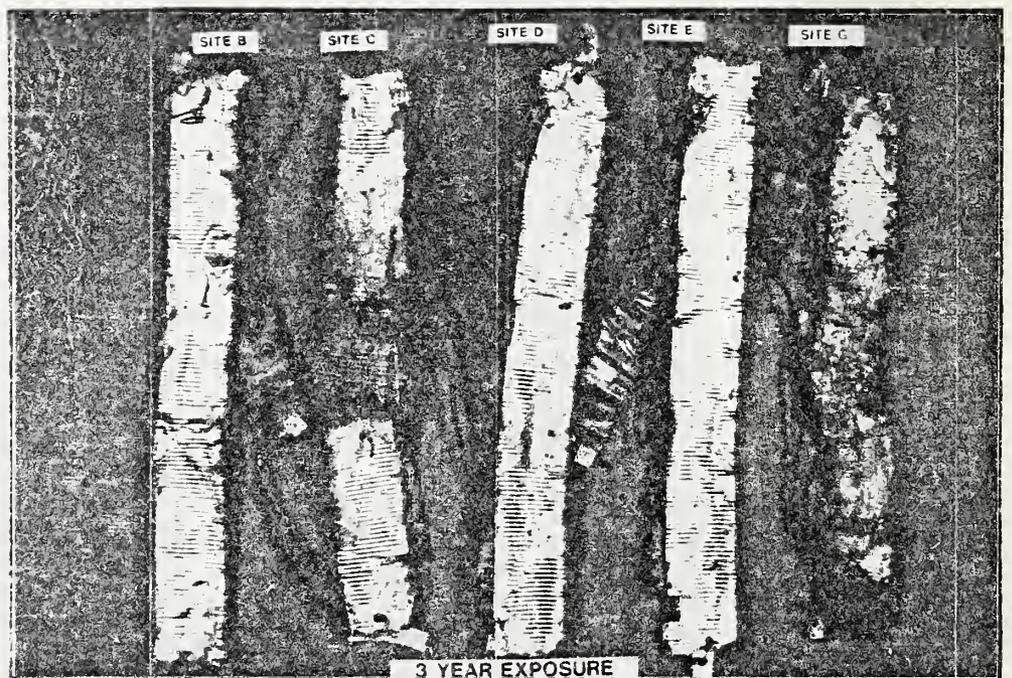
Figure 33. Inner Shield; System 88, Sites B,C,D,E, and G, left to right, exposed for three years. Coupling this system accelerated degradation on the specimens from Sites C and G.

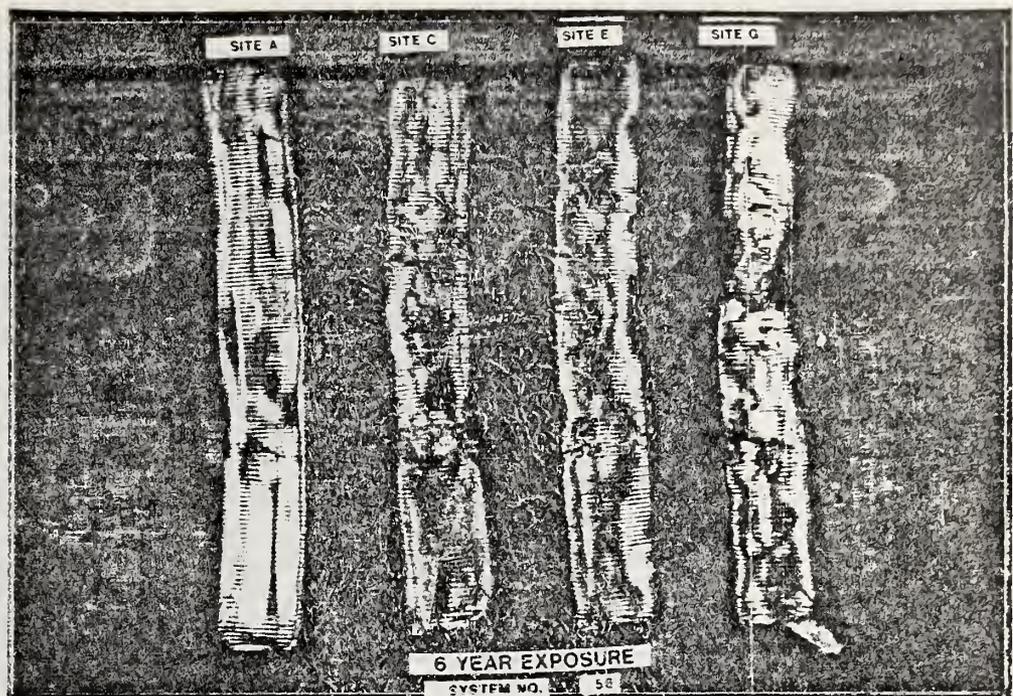
There was no degradation of the outer or inner shields of specimens exposed for six years at Site A and five years at Site D or of the outer shield on specimens buried for up to six years at Site C and four years at Site E. The outer shield was ELD or near ELD at the unjacketed window and/or ring areas on specimens exposed for four and six years at Site G. The inner shields were perforated due to localized corrosion after burial for four and six years at Site C and three, four, and six years at Site E. In general, the inner shield was at or near ELD on specimens exposed from two to six years at Site G.

Figure 34. Outer Shield; System 56, Sites A,C,E, and G, left to right, exposed for six years. Dark areas indicate corrosion on specimens with severe corrosion on the specimen from Site G at the window and ring areas.

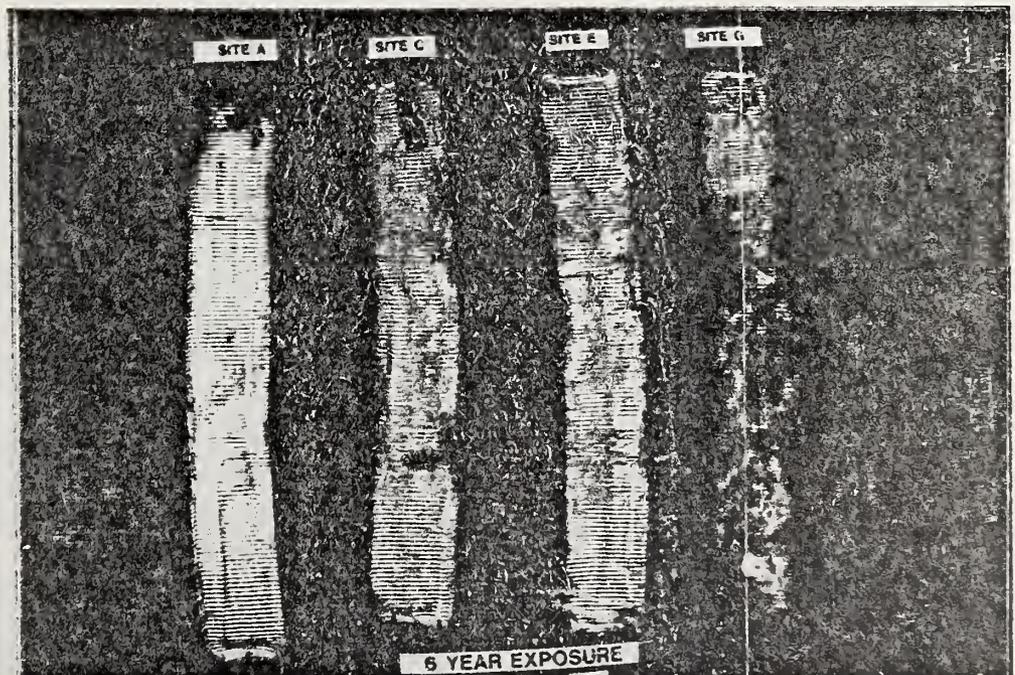
Figure 35. Inner Shield; System 56, Sites A,C,E, and G, left to right, exposed for six years. Severe degradation on the specimens from Sites C and G.

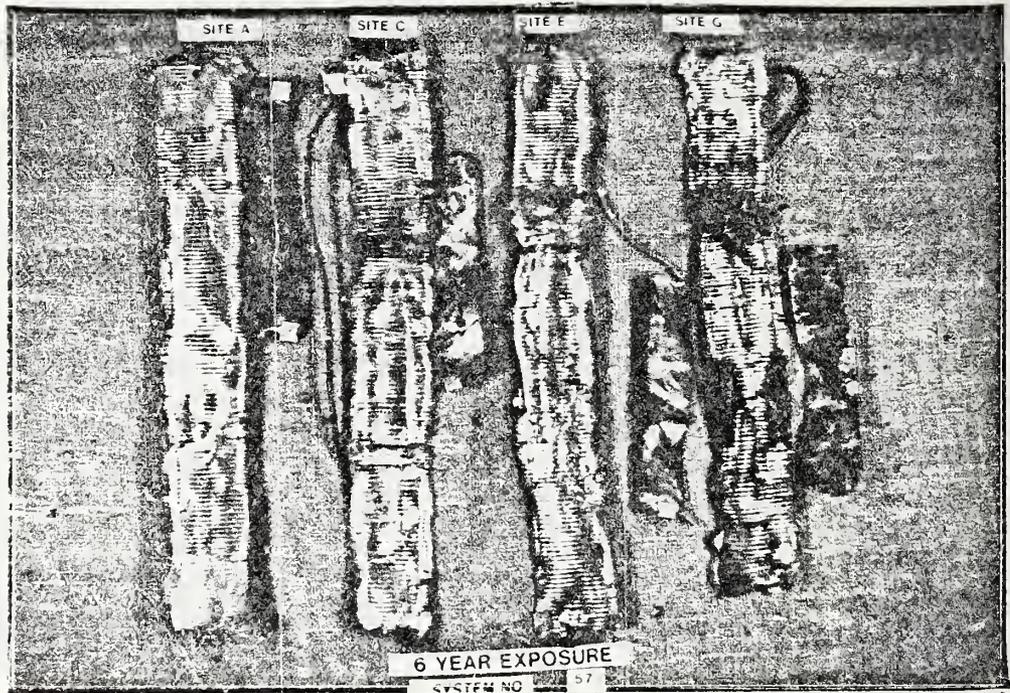
Figure 36. Outer Shield; System 57, Sites A,C,E, and G, left to right, exposed for six years. Coupling this system to copper accelerated corrosion on all specimens indicated by dark areas.

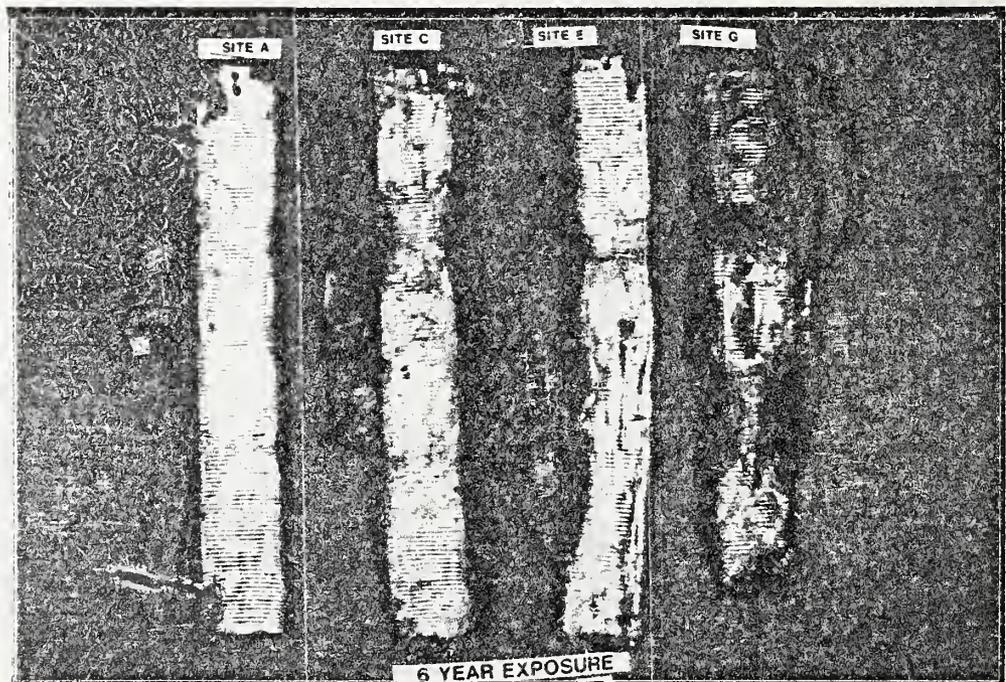
Figure 37. Inner Shield; System 57, Sites A,C,E, and G, left to right, exposed for six years. Coupling this system to copper accelerated degradation on the specimens from Sites C and G severely.
